Downtown Study Area Draft Statement of Blight

City of Helena

March 15, 2018

WGMGROUP™

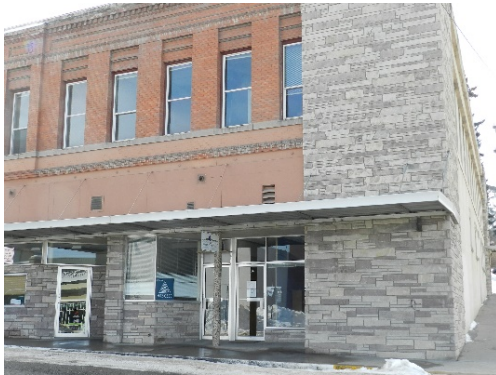
In the 1970s, it was popular to “update” older historic buildings by adding a layer of cladding to cover outmoded architectural details and/or to reinforce failing exteriors. Currently many owners across the nation are working to rid the cladding and restore or recreate original features.

Building on Fuller Street with cladding removed on upper floors

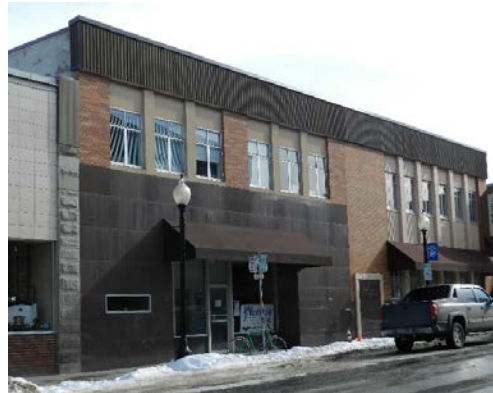
Building on Last Chance with various types of cladding

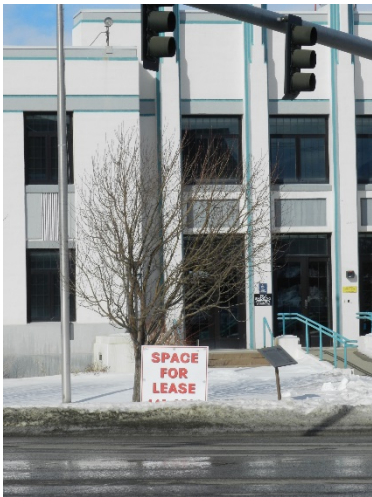
Armory Building at Lyndale and Last Chance

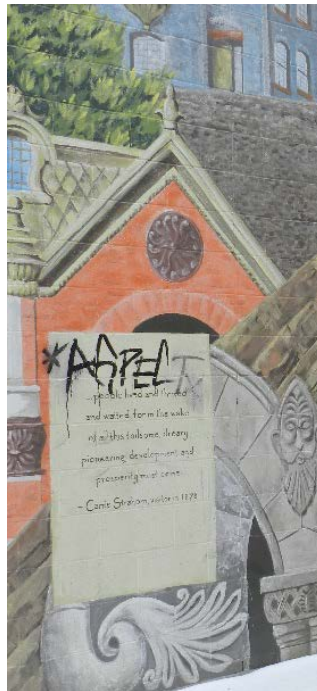
Graffiti on wall mural

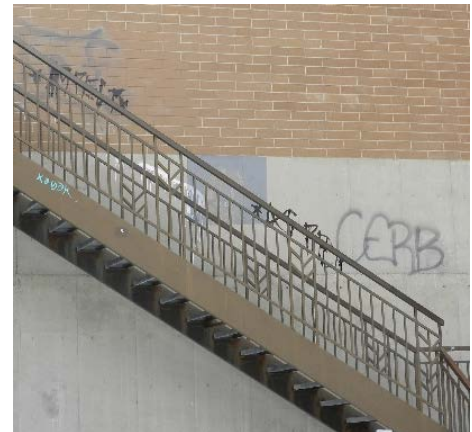
Graffiti of various types within Performance Square

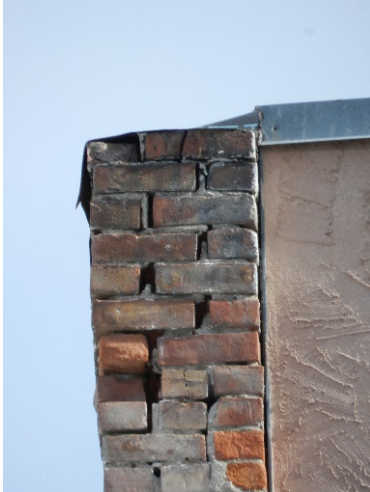
Brickwork that has lost mortar near the roofline of a downtown building

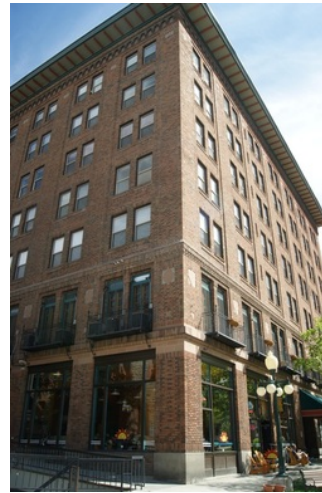
Nearly all commercial buildings in the study area have flat roofs. Snow and rain can create structural issues for these buildings over time. Parapets, the short walls around the flat roof, may deteriorate. Cornices, or overhanging eaves, are intended to throw rainwater free of a building's walls. They may need replacement over the long-term. The exact extent of the issue is unknown, but several buildings exhibit some stress from water, snow, and age. Over several weeks in 2017, significant work was done on the roof of the Placer Hotel, including replacement of cornices.

Example of a cornice at the top of the building (Placer Hotel)

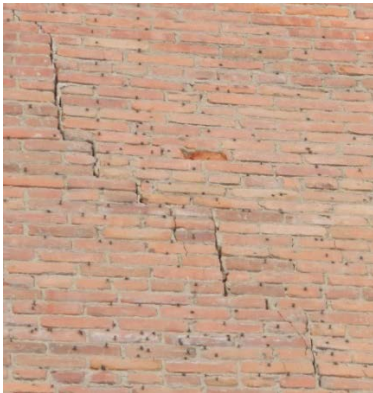
Downtown Helena is in a seismic zone equivalent to some in California. The 1935 Helena earthquake resulted in considerable damage, but many buildings survived although resulting in worse wear and tear. Bi-lateral cracking in walls could be a result of earth movement and may indicate potential issues for long-term structural viability.

Bi-lateral cracking in building historic downtown core

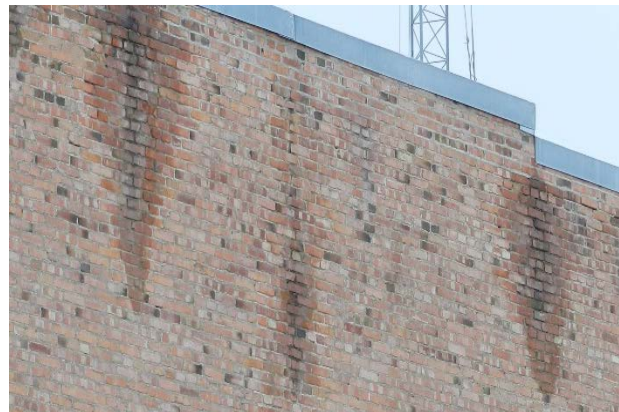
Water infiltrating building wall in historic downtown core

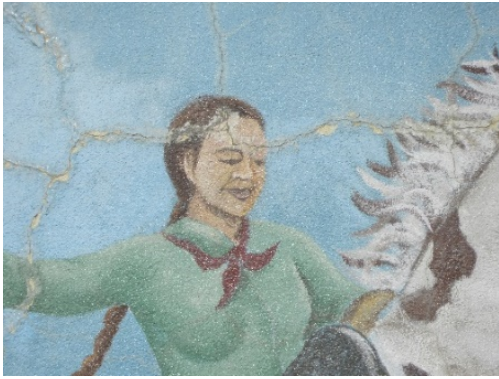
Downtown artwork completed or renovated during the 20th century urban renewal is also beginning to show signs of deterioration. The women’s mural, significant for its art and as a location for activities such as the mountain bike shuttle, is seriously deteriorating and in need of repair.

Cracking on Women's Mural

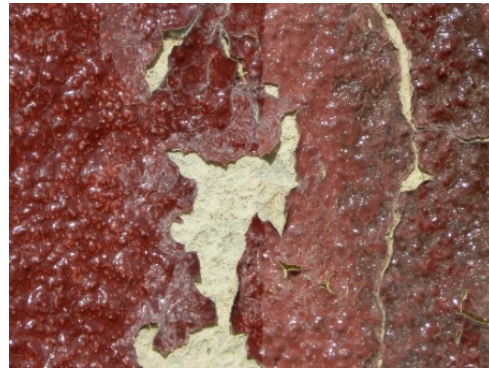
Close-up of peeling on Women's Mural

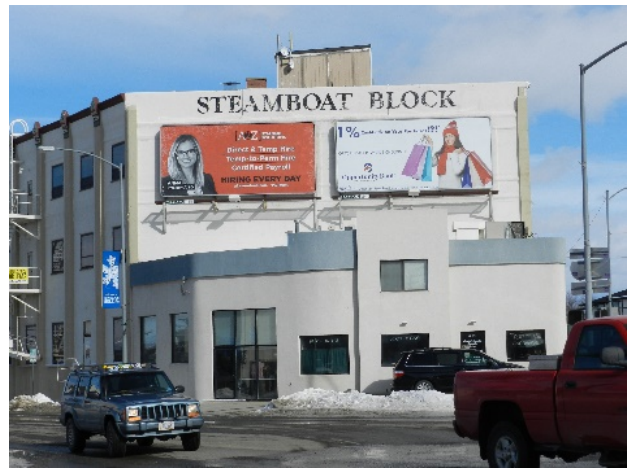
In many older buildings, windows are the only source of ventilation and natural light. Because many of the buildings in the historic downtown core are side-by-side, natural light is typically limited to front and back windows, possibly augmented with roof skylights. Many older buildings originally had windows that were downsized in later years. Boarding windows further eliminates natural lighting.

Steamboat Block (2018) with smaller windows

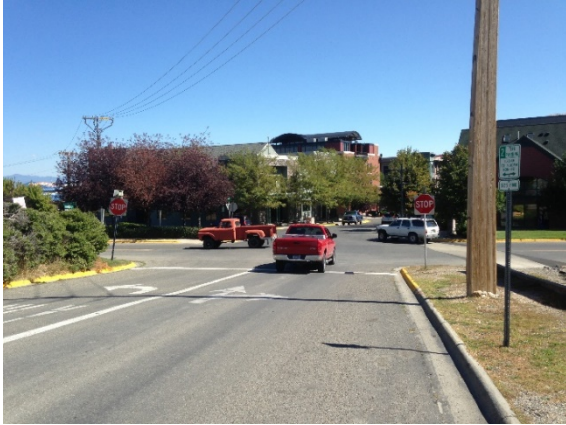
*Hauser Blvd looking east to Great Northern Towncenter
Note: Lack of pedestrian facilities*

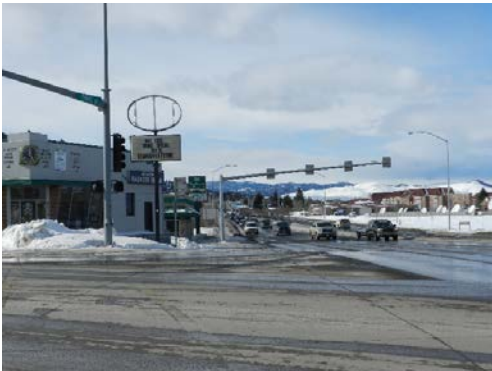
The major gateway into downtown at Last Chance and Highway 12 is also problematic for pedestrians. The crossing distance is very long without any refuge islands.

Intersection of Highway 12/Lyndale and N. Last Chance looking west (from First Interstate Bank corner)

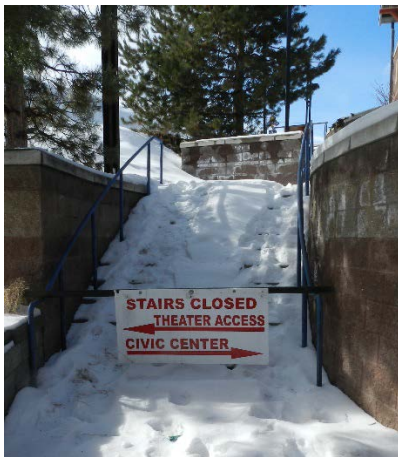
Defective, deteriorating, and unsafe pedestrian access is evident throughout the study area. Repairing can be difficult and expensive. The stairway next to the parking garage by the movie theater in the Great Northern Town Center has been closed for safety reasons due to soil subsidence. Many of Helena’s sidewalks are narrow, comfortably allowing for only single file, and forcing people to skirt into the street. Outside of the main retail areas and the mall, sloped driveway surfaces are numerous and interrupt the flat walking surface. Stamped concrete surfaces installed over the past decades are showing wear and tear. The unique brick and stone elements of the walking mall can be difficult to maintain to avoid significant tripping hazards. ADA facilities are lacking or substandard in the study area.

Unsafe stairway at Getchell Garage

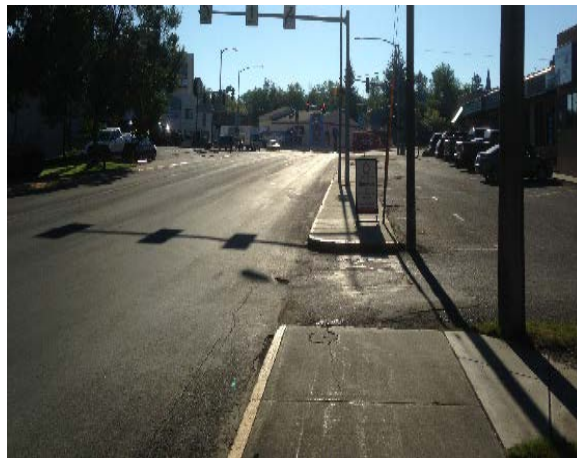
Examples of sloped driveway access on sidewalk (Neill ave)

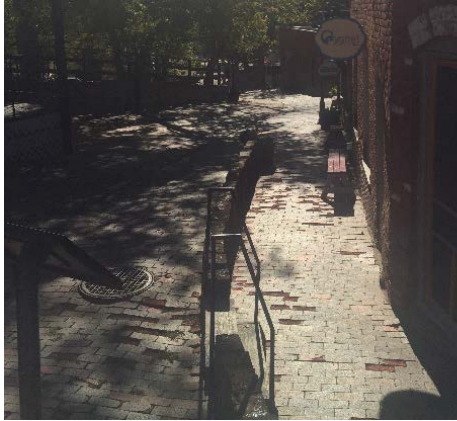
Missing Brickwork (Reeder's Alley)

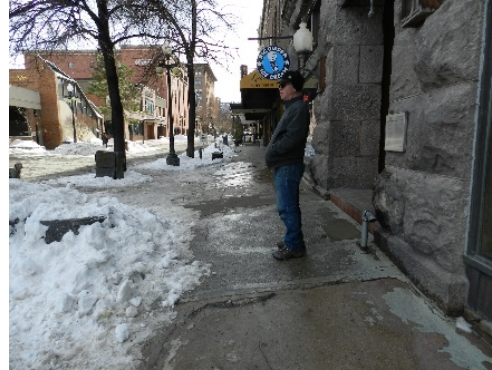
Sloped and cracking pavement in Walking mall

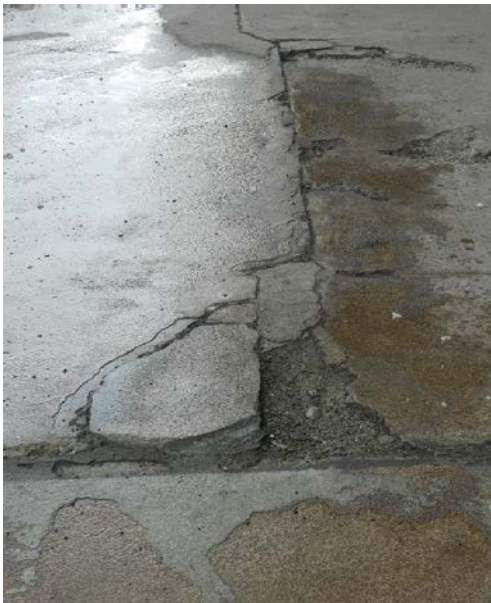
Sidewalk deterioration in study area

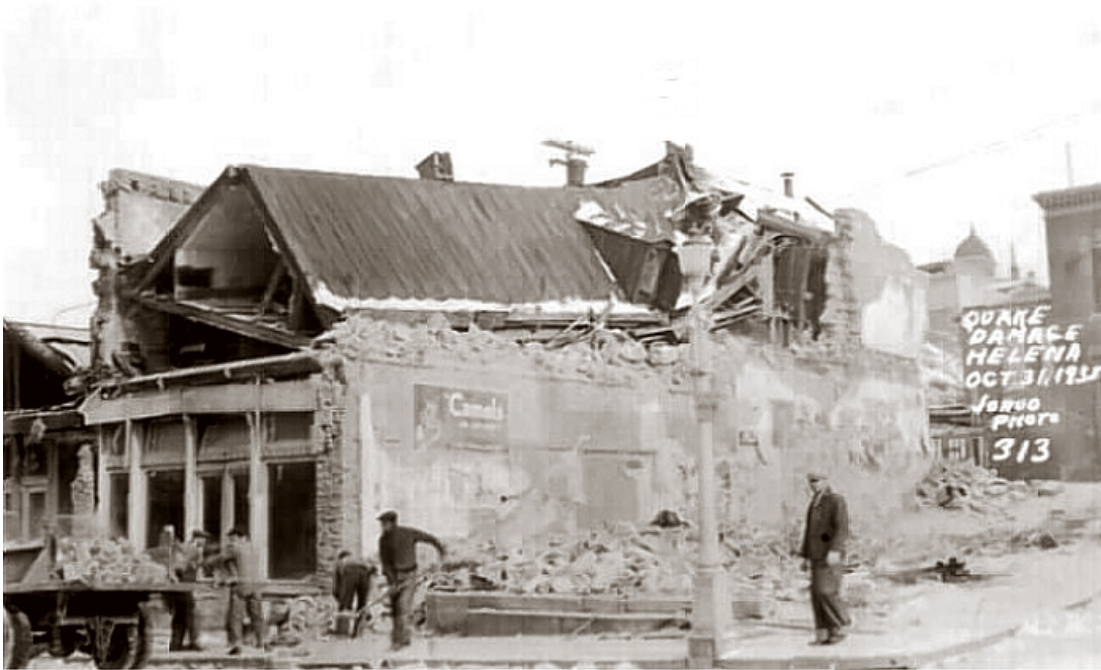
1935 Earthquake damage (Source: helenahistory.org)
