RESOLUTION NO. 20444

A RESOLUTION FINDING THAT A BLIGHTED AREA EXISTS WITHIN THE CITY OF HELENA, MONTANA, AND THAT REHABILITATION AND REDEVELOPMENT, OR A COMBINATION THEREOF, OF SUCH AREA IS NECESSARY IN THE INTERESTS OF PUBLIC HEALTH, SAFETY, MORALS, OR WELFARE OF THE RESIDENTS OF HELENA

Downtown Study Area Draft Statement of Blight

City of Helena

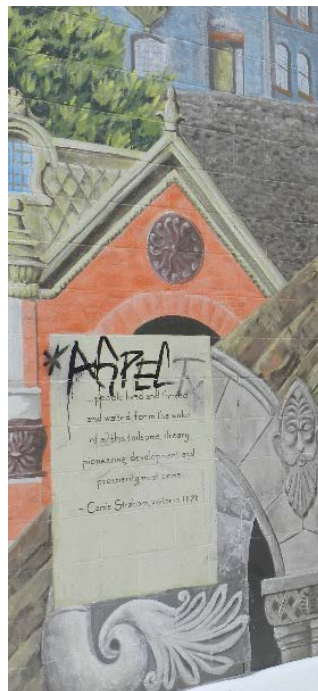
Boarded windows and graffiti on buildings, even those that are active and not vacant, gives an appearance of dilapidation. Helena has worked diligently to keep graffiti at bay, quickly removing it as it appears in city parks and public places. Within a single 12-hour period in 2017, dozens of properties in downtown were vandalized with graffiti. Much of the graffiti from this single incident remains in downtown, likely because removing it is very difficult and costly. Graffiti seems to foster new graffiti. Cost of clean-up can be in the thousands of dollars and detracts resources from other planned long-term deferred maintenance items.

Graffiti on wall mural

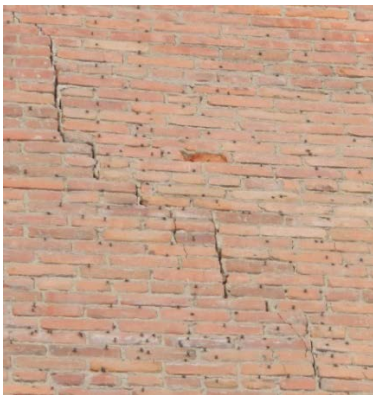
Downtown Helena is in a seismic zone equivalent to some in California. The 1935 Helena earthquake resulted in considerable damage, but many buildings survived although resulting in worse wear and tear. Bi-lateral cracking in walls could be a result of earth movement and may indicate potential issues for long-term structural viability.

Bi-lateral cracking in building historic downtown core

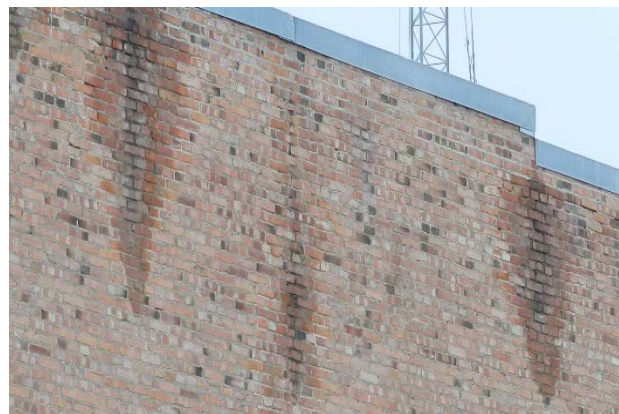
Water infiltrating building wall in historic downtown core
