2021 Helena Open Lands Trail Inspection Report

Prepared by: Prickly Pear Land Trust

Introduction

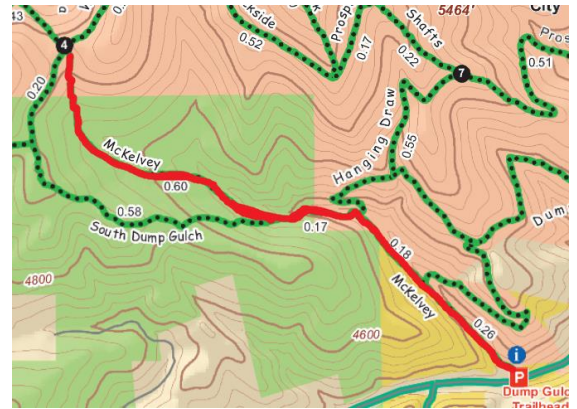
McKelvey Trail

a. Overview: McKelvey is a wide trail that runs up a gully starting from the Dump Gulch trailhead. It has a fall-line nature and as such requires the installation and maintenance of numerous drain dips. It provides access to Mount Helena as well as the Mount Helena Ridge trail. It crosses both City land as well as Forest Service property.

a. Brushed for sightlines

a. Requires annual drain maintenance and clearing due to the fall-line aspect. Trail is over 6' wide in most places so drains are generally larger and more time consuming to build/maintain.

b. Potential opportunities to reroute out of the gully to improve trail sustainability and improve user experience.

c. Bicycle speed can be a concern as grade remains constant throughout, trail does not provide natural speed control.

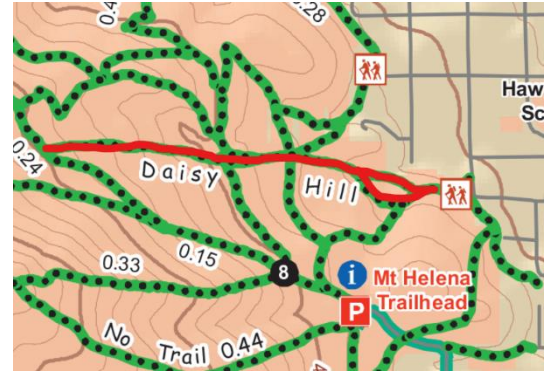
1. Trail Information
 - a. Overview: Daisy Hill is a relatively short trail on the northeast side of Mt. Helena, primarily accessed from neighborhood trailheads. It has switchbacks down low but a fall-line aspect as it heads up towards its junction with the Prairie trail.
 - b. Inspection Date: 6/5/2021
 - c. Park Name: Mt. Helena
 - d. Trail: Daisy Hill
 - e. Length: 3,471ft
2. Annual Maintenance
 - a. Brushing: **Completed**
 - b. Drainage: **Completed**
3. Trail Issues
 - a. None
4. Recommendations, Annual Needs, and Concerns
 - a. Upper fall-line section requires annual maintenance on the, approximately 20 or so, drains.
 - b. Fall-line could be rerouted to improve sustainability but holds up well with annual maintenance
 - c. Daisy Hill has many social trails and neighborhood connections, confusing to navigate.

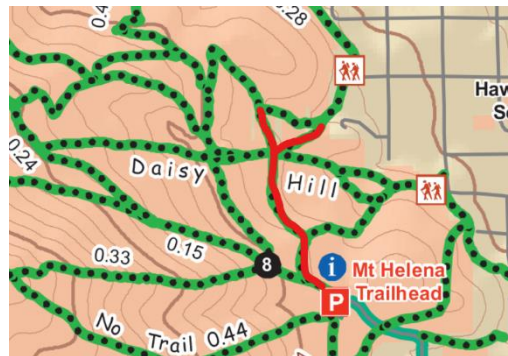
1. Trail Information
 - a. Overview: Bitterroot Way runs through the Daisy Hill area in a generally north-south fashion. Accessed via Mount Helena parking lot and neighborhood trails. Picnic area near Mount Helena trailhead.
 - b. Inspection Date: 6/5/2021
 - c. Park Name: Mt. Helena
 - d. Trail: Bitterroot Way
 - e. Length: 933ft
2. Basic Maintenance
 - a. Brushing: **Completed**
 - b. Drainage: **Completed**
3. Trail Issues
 - a. None
4. Recommendations, Annual Needs, and Concerns

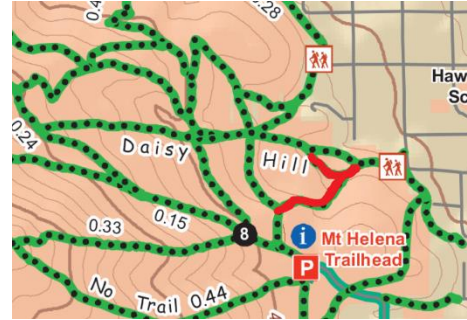
1. Trail Information
 - a. Overview: Connector accessed from the picnic area near Mount Helena trailhead that runs along the fence of the water tank and connects to the east end of Daisy Hill.
 - b. Inspection Date: 6/5/2021
 - c. Park Name: Mt. Helena
 - d. Trail: Bitterroot Way – Daisy Hill Connector
 - e. Length: 600ft
2. Basic Maintenance
 - a. Brushing: **Completed**
 - b. Drainage: **Completed**
3. Trail Issues
 - a. Need to clean out and improve drains on steep pitch down from picnic area
 - b. Need to brush along fenceline
4. Recommendations, Annual Needs, and Concerns
 - a. Tends to get brushy near fenceline
 - b. Monitor after rainfalls, steep fall-line from parking area

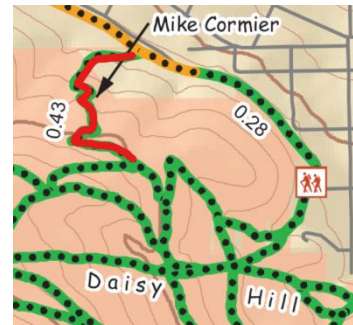
1. Trail Information
 - a. Overview: A steep access from LeGrande Cannon to the Daisy Hill area of Mt. Helena as well as the popular Ambrose and Prairie trails.
 - b. Inspection Date: 4/27/2021
 - c. Park Name: Mt. Helena
 - d. Trail: Mike Cormier
 - e. Length: 3,121ft
2. Basic Maintenance
 - a. Brushing: **Completed**
 - b. Drainage: **Completed**
3. Trail Issues
 - a. Brushed for Sightlines
4. Recommendations, Annual Needs, and Concerns
 - a. Steeper trail, drainage and trail should be monitored for erosion annually
 - b. Monitor fall line social trail forming

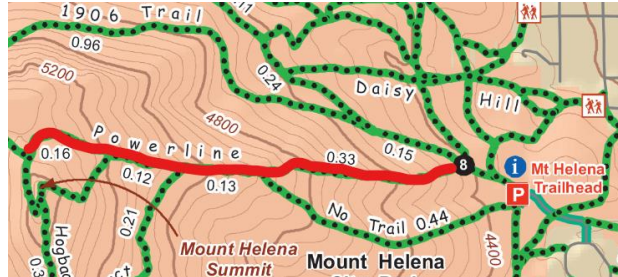
1. Trail Information
 - a. Overview: Steepest trail in the system, wide, fall-line. It is the most direct route to the Mt. Helena summit and one of the most popular hikes in the trail system. No downhill bike use permitted. Bicycles not recommended for uphill travel. Lots of waterbars to manage drainage.
 - b. Inspection Date: 4/27/2021
 - c. Park Name: Mt. Helena
 - d. Trail: Powerline
 - e. Length: 3,777
2. Basic Maintenance
 - a. Brushing: **Completed**
 - b. Drainage: **Completed**
3. Trail Issues
 - a. None
4. Recommendations, Annual Needs, and Concerns
 - a. Needs annual maintenance to maintain the waterbars, a challenge to stay ahead of drainage issues on this trail
 - b. Waterbars monitored annually to fix loose rocks, steps, etc.
 - c. Trail widening should be monitored

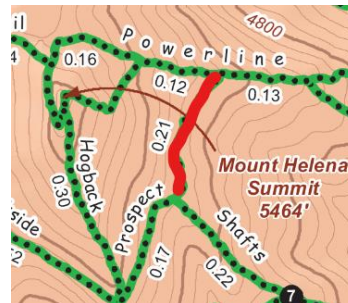
Powerline/ Prospect Shafts Connector

1. Trail Information
 - a. Overview: A contour trail connecting the steep Powerline and Prospect Shafts trails. Bicycle traffic not recommended as only connection is to Powerline which has bicycle restrictions.
 - b. Inspection Date: 6/2/2021
 - c. Park Name: Mt. Helena
 - d. Trail: Powerline to Prospect Shafts Connector
 - e. Length: 1,044ft
2. Basic Maintenance:
 - a. Brushing: **Completed**
 - b. Drainage: **Completed**
3. Trail Issues:
 - a. None
4. Recommendations, Annual Needs, and Concerns:
 - a. Monitor rocky section on south side of trail, may need widening and brushing in future

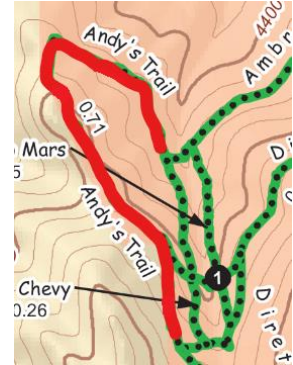
1. Trail Information
 - a. Overview: This trail, built in 2015, follows a route along the northwestern boundary of Mt. Helena City Park. Connects to recently acquired LeGrande (Whyte property) parcels.
 - b. Inspection Date: 5/27/2021
 - c. Park Name: Mt. Helena
 - d. Trail: Andy's
 - e. Length: 3,143ft
2. Basic Maintenance
 - a. Brushing: **Completed**
 - b. Drainage: **Completed**
3. Trail Issues:
 - a. Narrow, outsloped tread in some places
 - b. Fall-line section eroding
 - c. Brushed for sightlines
4. Recommendations, Annual Needs, and Concerns:
 - a. Add drainage to fall-line section, low priority
 - b. Widen/flatten tread where needed, low priority

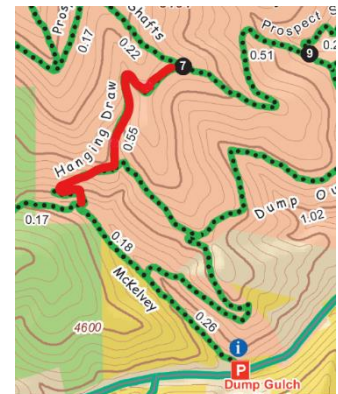
1. Trail Information
 - a. Overview: A steep climb greets people coming off of McKelvey trail before flattening into a manageable grade to the junction with Prospect Shafts. Accessed primarily via Dump Gulch trailhead.
 - b. Inspection Date: 7/21/2021
 - c. Park Name: Mt. Helena
 - d. Trail: Hanging Draw
 - e. Length: 2,902ft
2. Basic Maintenance
 - a. Brushing: **Completed**
 - b. Drainage: **Completed**
3. Trail Issues
 - a. Some confusing social trails, needs signage or social trail closures
 - b. Brushed for sightlines
4. Recommendations, Annual Needs, and Concerns
 - a. Add sign at confusing social trail junction
 - b. Close or incorporate social trail connecting to Prospect shafts

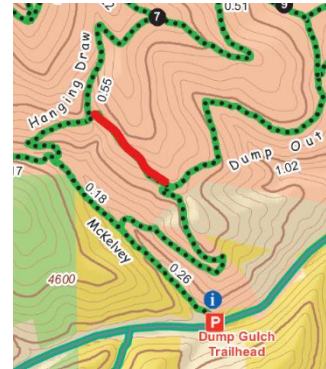
Hanging Draw to Dump Out Connector

1. Trail Information
 - a. Overview: Connector trail between Dump Out and Hanging Draw
 - b. Inspection Date: 5/27/2021
 - c. Park Name: Mt. Helena
 - d. Trail: Hanging Draw connector
 - e. Length: 1,207ft
2. Basic Maintenance
 - a. Brushing: **Completed**
 - b. Drainage: **Completed**
3. Trail Issues
 - a. Rock section loosing outer edge
 - b. Brushed for sightlines
4. Recommendations, Annual Needs, and Concerns
 - a. Monitor for brushing needs
 - b. Rock section in need of crib structure

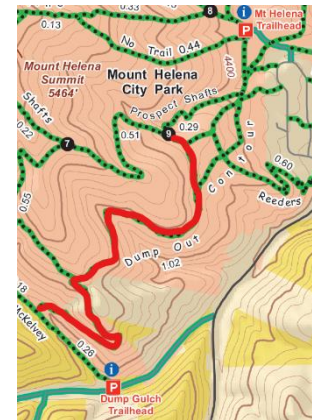
1. Trail Information
 - a. Overview: Rocky contour trail that connects from Dump Gulch trailhead to Prospect Shafts trail.
 - b. Inspection Date: 5/27/2021
 - c. Park Name: Mt. Helena
 - d. Trail: Dump Out
 - e. Length: 6,045ft
2. Basic Maintenance
 - a. Brushing: **Completed**
 - b. Drainage: **Completed**
3. Trail Issues
 - a. Brushed for sightlines
4. Recommendations, Annual Needs, and Concerns
 - a. Has a tendency to narrow on steep sidehill sections, monitor

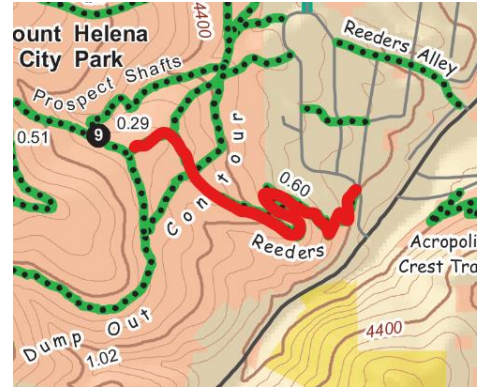
1. Trail Information
 - a. Overview: Steep trail that connects from Reeder's Village Drive to Contour and Dump Out trails
 - b. Inspection Date: 5/13/2021
 - c. Park Name: Mt. Helena
 - d. Trail: Reeders
 - e. Length: 3,055ft
2. Basic Maintenance
 - a. Brushing: **Completed**
 - b. Drainage: **Completed**
3. Trail Issues
 - a. None
4. Recommendations, Annual Needs, and Concerns
 - a. Monitor brushing needs with consideration for sightlines
 - b. May require retread in coming years

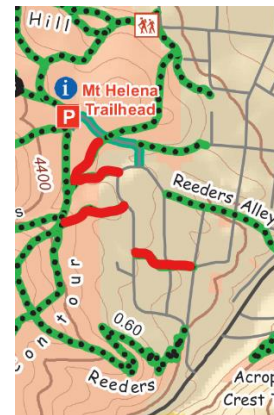
Reeders Village Trails

1. Trail Information
 - a. Overview: These trails connect the neighborhood of Reeder's Village to Mount Helena. Mix of singletrack connectors and decomposed granite surfaced trails.
 - b. Inspection Date: 6/7/2021
 - c. Park Name: Mt. Helena
 - d. Trail: Reeders Village, Reeders Alternate, Reeders Cut-off, Carriage Lane to South Harrison
 - e. Length: 1,542ft, 463ft, 1,552ft, 475ft
2. Basic Maintenance
 - a. Brushing: **Completed**
 - b. Drainage: **Completed**
3. Trail Issues
 - a. Numerous social trails in area
 - b. Weeds in surfaced trails
4. Recommendations, Annual Needs, and Concerns
 - a. Treat weeds growing in surfaced trails
 - b. Half resurfaced August 2021
 - i. Further surfacing needs

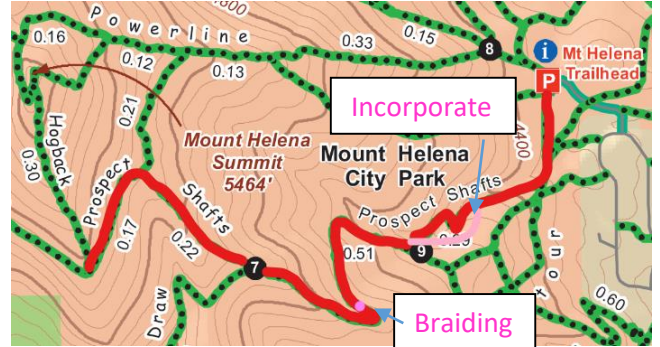
1. Trail Information
 - a. Overview: This trail is a combination of single-track and old road bed that alternates between steep climbs and relief contours. Accessed via Mount Helena trailhead.
 - b. Inspection Date: 4/8/2021
 - c. Park Name: Mt. Helena
 - d. Trail: Prospect Shafts
 - e. Length: 7,022ft
2. Basic Maintenance
 - a. Brushing: **Completed**
 - b. Drainage: **Completed**
3. Trail Issues
 - a. Minor trail braiding
 - b. Brushed for sightlines
4. Recommendations, Annual Needs, and Concerns
 - a. Needs annual drain maintenance, some steep sections
 - b. GPS needs to be looked at lower end and map needs correcting
 - i. Incorporate current main trail not indicated on the map in lower section

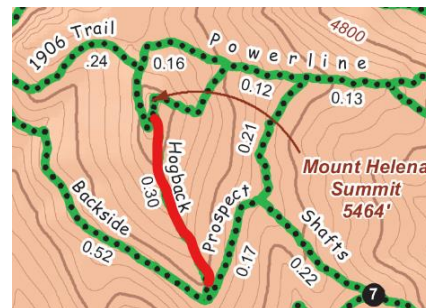
1. Trail Information
 - a. Overview: Steep, rocky trail connecting Prospect Shafts to Mount Helena summit. Numerous waterbars to manage drainage.
 - b. Inspection Date: 7/13/2021
 - c. Park Name: Mt. Helena
 - d. Trail: Hogback
 - e. Length: 2,436ft
2. Basic Maintenance
 - a. Brushing: **Completed**
 - b. Drainage: **Completed**
3. Trail Issues
 - a. None
4. Recommendations, Annual Needs, and Concerns
 - a. Needs annual maintenance on waterbars

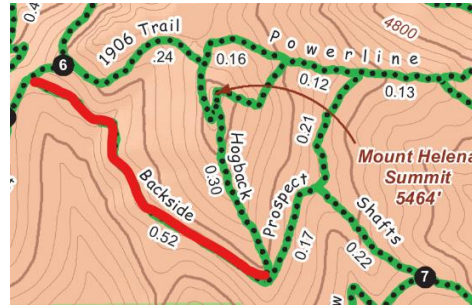
1. Trail Information
 - a. Overview: Contour trail running along the backside of Mount Helena.
 - b. Inspection Date: 3/30/2021
 - c. Park Name: Mt. Helena
 - d. Trail: Backside
 - e. Length: 2,693ft
2. Basic Maintenance
 - a. Brushing: **Completed**
 - b. Drainage: **Completed**
3. Trail Issues
 - a. None
4. Recommendations, Annual Needs, and Concerns
 - a. Monitor for brushing

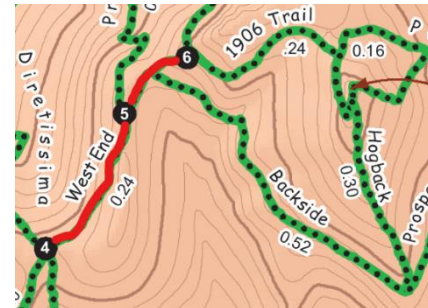
1. Trail Information
 - a. Overview: Connector trail between the Mt. Helena Ridge trail and 1906 trail.
 - b. Inspection Date: 4/21/2021
 - c. Park Name: Mt. Helena
 - d. Trail: West End
 - e. Length: 1,819ft
2. Basic Maintenance
 - a. Brushing: **Completed**
 - b. Drainage: **Completed**
3. Trail Issues
 - a. Brushed for sightlines
4. Recommendations, Annual Needs, and Concerns
 - a. Monitor for brushing needs
 - b. Outslomed sections may require retread in the next few years

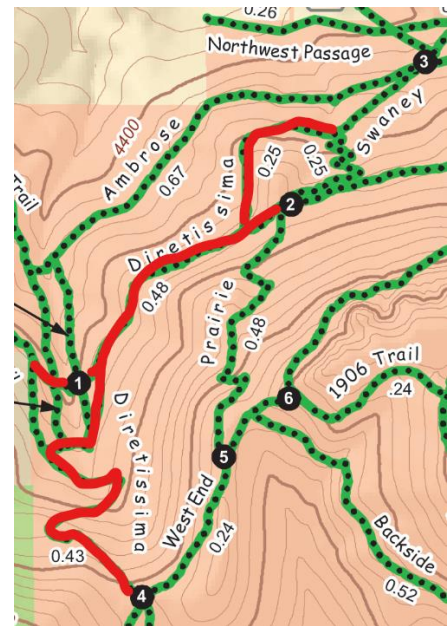
1. Trail Information
 - a. Overview: Climbs northwest side of Mt. Helena, connecting between Swaney and West End trails.
 - b. Inspection date: 4/8/2021
 - c. Park Name: Mt. Helena
 - d. Trail: Diretissima
 - e. Length: 6,044ft
2. Basic Maintenance
 - a. Brushing: **Completed**
 - b. Drainage: **Completed**
3. Trail Issues
 - a. Social Trail between Diretissima and Ambrose
 - b. Brushed for sightlines
4. Recommendations, Annual Needs, and Concerns
 - a. Monitor steep section near top for drainage erosion issues
 - b. Correct GPS on map

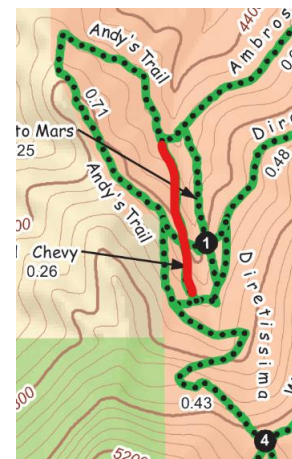
1. Trail Information
 - a. Overview: Short, steep, wide fall-line trail
 - b. Inspection Date: 5/27/2021
 - c. Park Name: Mt. Helena
 - d. Trail: Old Chevy
 - e. Length: 2,631ft
2. Basic Maintenance
 - a. Brushing: **Completed**
 - b. Drainage: **Completed**
3. Trail Issues
 - a. Brushed for sightlines

4. Recommendations, Annual Needs, and Concerns
 - a. Because of its fall-line nature needs to be monitored annually for erosion concerns
 - b. Susceptible to damage after big storms
 - c. Old Chevy needs trash cleaned out of it
 - d. Trail widening above road bed section

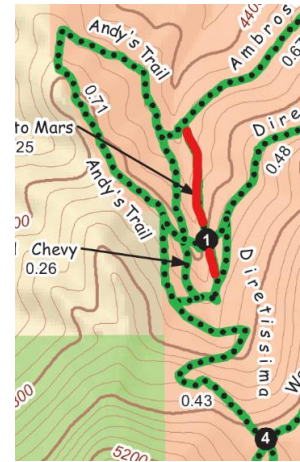
1. Trail Information
 - a. Overview: Short, steep, wide fall-line trail
 - b. Inspection Date: 5/27/2021
 - c. Park Name: Mt. Helena
 - d. Trail: Road to Mars
 - e. Length: 2,123ft
2. Basic Maintenance
 - a. Brushing: **Completed**
 - b. Drainage: **Completed**
3. Trail Issues
 - a. Brushed for sightlines
4. Recommendations, Annual Needs, and Concerns
 - a. Because of its fall-line nature needs to be monitored annually for erosion concerns
 - b. Susceptible to damage after big storms

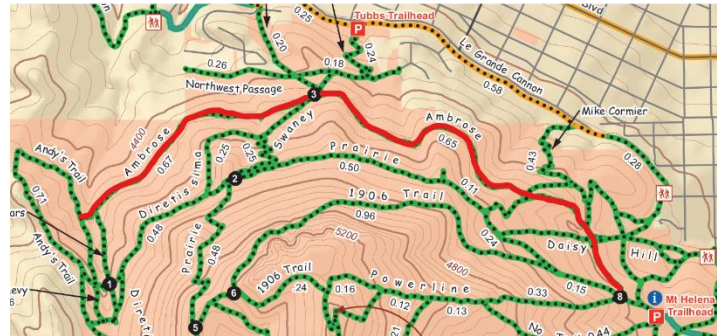
1. Trail Information
 - a. Overview: The lowest of 3 contour trails on the north side of Mt. Helena
 - b. Inspection Date: 5/14/2021
 - c. Park Name: Mt. Helena
 - d. Trail: Ambrose
 - e. Length: 7,226ft
2. Basic Maintenance
 - a. Brushing: **Completed**
 - b. Drainage: **Completed**
3. Trail Issues
 - a. Minor localized trail braiding and outslipping
 - b. Some social trails spurring off of trail
 - c. Brushed for sightlines
4. Recommendations, Annual Needs, and Concerns
 - a. Needs retread in next few years, irrelevant if becomes ADA trail
 - b. Adopt "Old Ambrose" and Water tank connector and add to map
 - c. Monitor lumpy section from spring

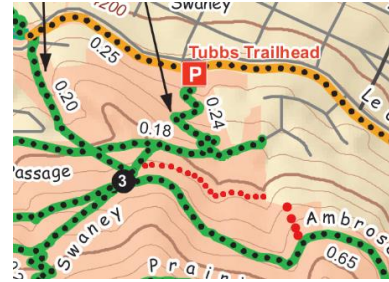
“Old Ambrose” and Ambrose watertank connector

1. Trail Information:
 - a. Overview: Connector trails that connect to the watertank area and Ambrose trail
 - b. Inspection Date:
 - c. Park Name: Mt. Helena
 - d. Trail: Old Ambrose, Watertank Connector
 - e. Length: 758ft, 275ft
2. Basic Maintenance
 - a. Brushing: **Completed**
 - b. Drainage: **Completed**
3. Trail Issues
 - a. Needs to be added to trail map
 - b. Brushed for sightlines
4. Recommendations, Annual Needs, and Concerns
 - a. GPS and add to map
 - b. Monitor fall-line trail from watertank

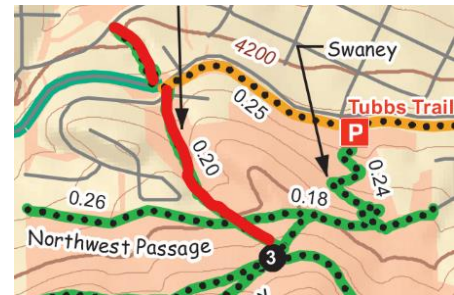
1. Trail Information
 - a. Overview: Steep neighborhood connector from Reber Road and LeGrande Cannon
 - b. Inspection Date: 5/27/2021
 - c. Park Name: Mt. Helena
 - d. Trail: Panhandle
 - e. Length: 1,000ft
2. Basic Maintenance
 - a. Brushing: **Completed**
 - b. Drainage: **Completed**
3. Trail Issues
 - a. Needs drainage added in lower section
 - b. Brushed for sightlines
4. Recommendations, Annual Needs, and Concerns
 - a. Monitor drainage

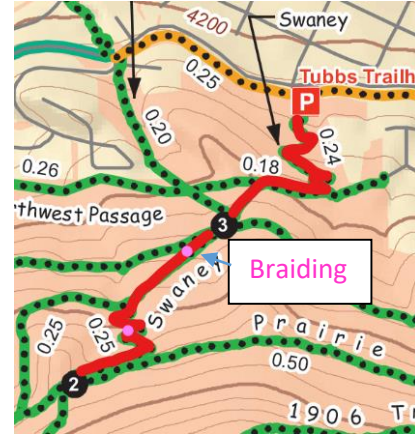
- Trail Information
 - Overview: Swaney switchbacks up the north side of Mt. Helena until its terminus with the Prairie Trail. Access via Tubbs trailhead.
 - Inspection Date: 4/21/2021
 - Park Name: Mt. Helena
 - Trail: Swaney
 - Length: 4,311ft
- Basic Maintenance
 - Brushing: **Completed**
 - Drainage: **Completed**
- Trail Issues
 - Some social trails leaving off of switchbacks
 - Braiding down low, Spring 2021 project to reclaim trail
 - Localized trail outsloping
 - Brushed for sightlines
- Recommendations, Annual Needs, and Concerns
 - Fix braiding and retread where needing
 - Cupping on initial switchbacks, needs extensive drainage and retread work

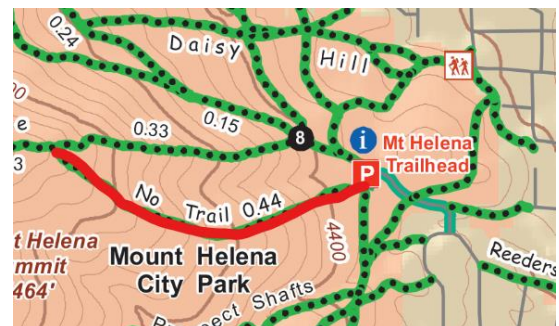
- Trail Information
 - Overview: Adjacent to Powerline trail, also a fall-line trail with numerous waterbars. Narrower and more shaded than Powerline.
 - Inspection Date: 4/8/2021
 - Park Name: Mt. Helena
 - Trail: No Trail
 - Length: 2,800ft
- Basic Maintenance
 - Brushing: **Completed**
 - Drainage: **Completed**
- Trail Issues
 - None
- Recommendations, Annual Needs, and Concerns
 - Fall-line trail, requires drain and waterbar maintenance annually
 - Monitor for brushing needs

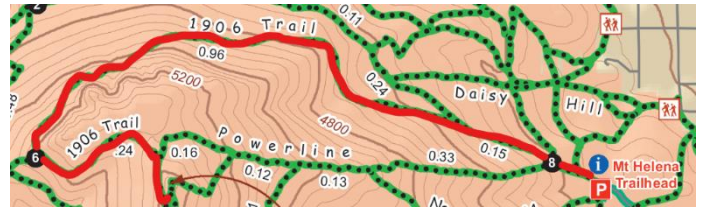
- Trail Information
 - Overview: This is Helena's most popular hiking trail, wide and sustainable. Bicycles may only travel this trail in uphill direction.
 - Inspection Date: 4/21/2021
 - Park Name: Mt. Helena
 - Trail: 1906
 - Length: 8,096ft
- Basic Maintenance
 - Brushing: **Completed**
 - Drainage: **Completed**
- Trail Issues
 - Some social trails between 1906 and Prairie
 - Becoming outsloped, filling in
 - Brushed for sightlines
- Recommendations, Annual Needs, and Concerns
 - Close or adopt social trails
 - Needs retread work in next few years
 - Cleaned out drains, restored old filled in drains spring 2021

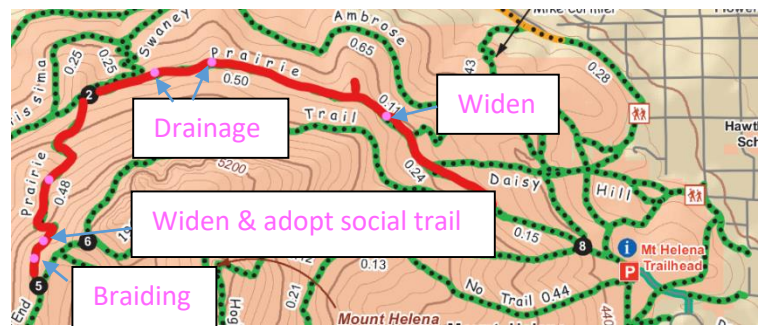
- Trail Information
 - Overview: Trail parallels 1906 lower on the mountain before switchbacking up to join 1906 near the summit.
 - Inspection Date: 4/8/2021
 - Park Name: Mt. Helena
 - Trail: Prairie
 - Length: 7,889ft
- Basic Maintenance
 - Brushing: **Completed**
 - Drainage: **Completed**
- Trail Issues
 - Social trails between Prairie and 1906
 - Localized outsloping, braiding
 - Brushed for sightlines
- Recommendations, Annual Needs, and Concerns
 - Retread required in next year or two
 - Close/disguise social trail accesses, Fall 2020 project
 - Add and repair drainage on fall-line section
 - Adopt the uppermost social trail between 1906 and Prairie

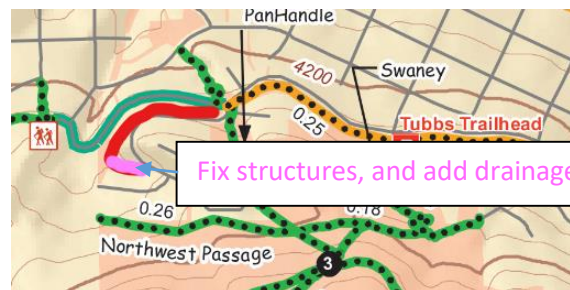
Westridge Trail

1. Trail Information
 - a. Overview: Single track trail that parallels Le Grande Cannon Blvd. Accesses Reber subdivision.
 - b. Inspection Date: 7/19/2021
 - c. Park Name: Mt. Helena
 - d. Trail: Westridge
 - e. Length: 2,022ft
2. Basic Maintenance
 - a. Brushing: **Completed**
 - b. Drainage: **Completed**
3. Trail Issues
 - a. Needs to be added to paper map
 - b. Rock structures need to be fixed and drainage improved in gully accessing Reber Rd. Trail needs to be widened in some places as well.
4. Recommendations, Annual Needs, and Concerns
 - a. Fix rock structures and drainage in gully accessing Reber Rd.

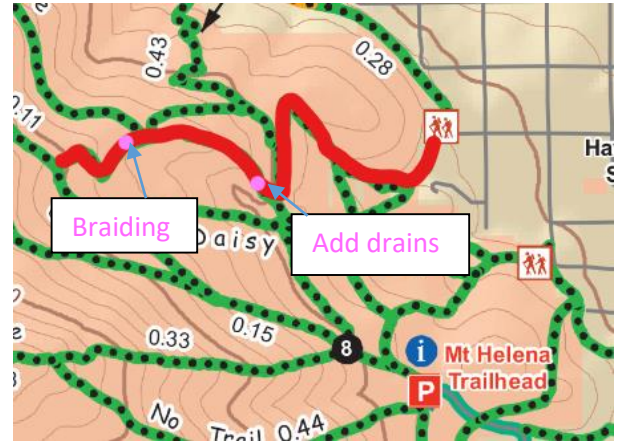
1. Trail Information
 - a. Overview: Mt. Helena Daisy Hill area trail that passes by an old Quarry, accesses Ambrose and Prairie trails.
 - b. Inspection Date: 6/5/2021
 - c. Park Name: Mt. Helena
 - d. Trail: Quarry
 - e. Length: 1,766ft
2. Basic Maintenance
 - a. Brushing: **Completed**
 - b. Drainage: **Completed**
3. Trail Issues
 - a. No drainage on steep pitch near Quarry
 - b. Localized braiding
4. Recommendations, Annual Needs, and Concerns
 - a. Add drains to steep pitch near Quarry
 - b. Fix braiding

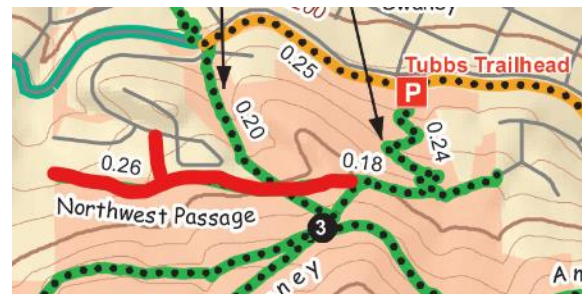
1. Trail Information
 - a. Overview: Contour trail above the Tubbs trailhead, connects to new LeGrande additions
 - b. Inspection Date: 7/19/2021
 - c. Park Name: Mt. Helena
 - d. Trail: Northwest Passage
 - e. Length: 1,900ft
2. Basic Maintenance
 - a. Brushing: **Completed**
 - b. Drainage: **Completed**
3. Trail Issues
 - a. Add Reber Rd. connection to map
4. Recommendations, Annual Needs, and Concerns
 - a. Look at connections to new LeGrande pieces, see Whyte assessment
 - b. Update map data

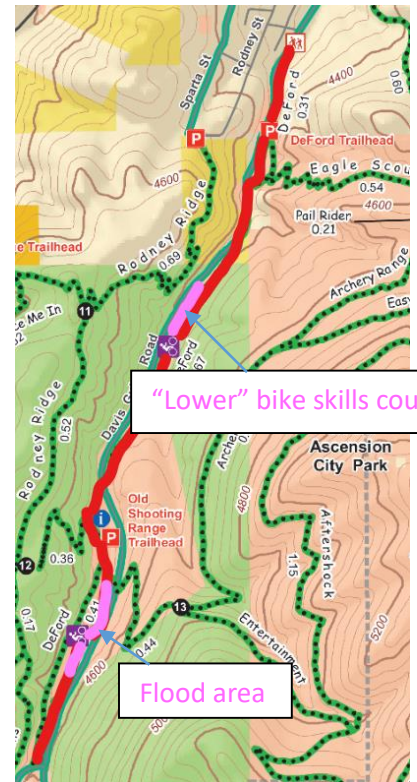
- a. Overview: Also locally known as the "woodchip trail" the portion of this trail between the DeFord Trailhead and Old Shooting Range Trailhead is wide and relatively flat. South of the Old Shooting Range parking lot transitions into a single track trail that connects to Dry Gulch.
- b. Inspection Date: 6/4/2021
- c. Park Name: Mt. Ascension
- d. Trail: Deford
- e. Length: 7,242ft

- a. Brush south end
- b. Periodically floods south of OSR parking lot
- c. Davis Gulch "lower" lower bike skills course needs formal action, being reviewed by working group 2021

- a. Raise trail south of OSR lot to manage water
- b. Professionally build "lower" bike skills course
- c. Fence out "lower" bike skills course
- d. Note that this trail was being reviewed by a working group in 2021 and may undergo some changes in the future

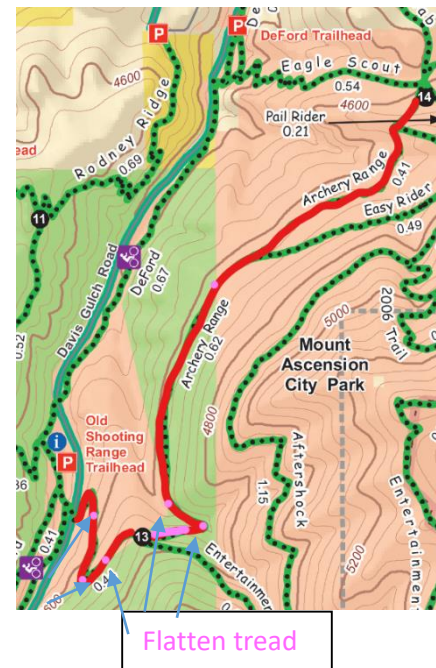
1. Trail Information
 - a. Overview: Contour trail that connects from Eagle Scout trail to the Old Shooting Range parking lot. Crosses USFS management as well.
 - b. Inspection Date: 6/18/2021
 - c. Park Name: Mt. Ascension
 - d. Trail: Archery Range
 - e. Length: 6,287ft
2. Basic Maintenance
 - a. Brushing: **Completed**
 - b. Drainage: **Completed**
3. Trail Issues
 - a. Some braiding and outsloping
4. Recommendations, Annual Needs, and Concerns
 - a. Brush hairpin near Entertainment trail for sightlines
 - b. Retread sections
 - c. Repair braiding

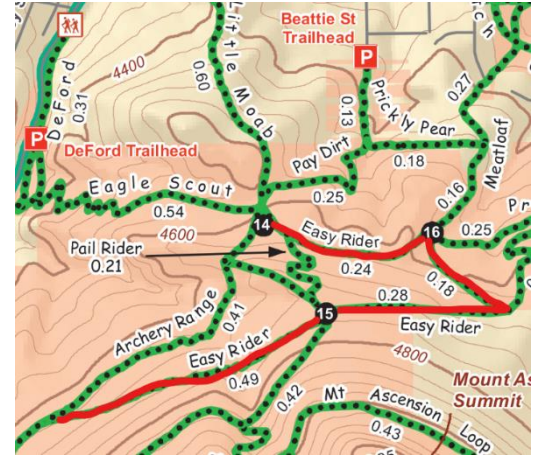
1. Trail Information
 - a. Overview: Uses an old access road bed for its northern section and turns to gentle single track as it crosses 2006 trail and approaches Archery Range.
 - b. Inspection Date: 6/17/2021
 - c. Park Name: Mt. Ascension
 - d. Trail: Easy Rider
 - e. Length: 6,283ft
2. Basic Maintenance
 - a. Brushing: **Completed**
 - b. Drainage: **Completed**
3. Trail Issues
 - a. None
4. Recommendations, Annual Needs, and Concerns
 - a. Examine social trails

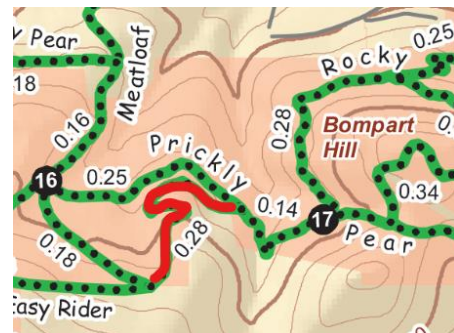
Easy Rider to Prickly Pear Connector

1. Trail Information
 - a. Overview: A new connector built in 2018, this short trail offers a single-track connector from the Bompert area to Mt. Ascension or vice-versa
 - b. Inspection Date: 6/17/2021
 - c. Park Name: Mt. Ascension
 - d. Trail: Easy Rider Prickly Pear Connector
 - e. Length: 1,242ft
2. Basic Maintenance
 - a. Brushing: **Completed**
 - b. Drainage: **Completed**
3. Trail Issues
 - a. None
4. Recommendations, Annual Needs, and Concerns
 - a. Needs retread in the next few years
 - b. Add to paper map
 - c. Monitor Social trail

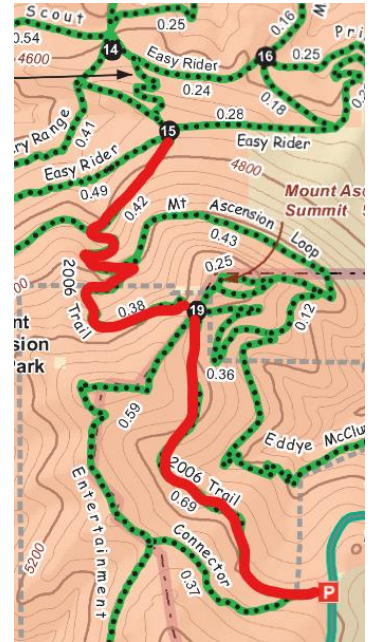
1. Trail Information
 - a. Overview: 2006 Trail is the primary access to the Mt. Ascension summit. Can be accessed via the north face of Mt. Ascension or by Arrowroot Drive on the backside.
 - b. Inspection Date: 5/11/2021
 - c. Park Name: Mt. Ascension
 - d. Trail: 2006
 - e. Length: 7,342ft
2. Basic Maintenance
 - a. Brushing: **Completed**
 - b. Drainage: **Completed**
3. Trail Issues
 - a. Widening in sections, some steep pitches
4. Recommendations, Annual Needs, and Concerns
 - a. Monitor section from Arrowroot Dr. to Mt. Ascension for narrowing and outslipping tread

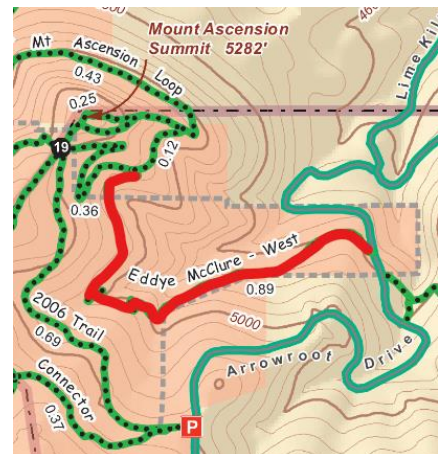
Eddy McClure West

1. Trail Information
 - a. Overview: Eddy - West descends the southeast side of Mt. Ascension and provides an alternate to the more popular 2006 trail.
 - b. Inspection Date: 4/12/2021
 - c. Park Name: Mt. Ascension
 - d. Trail: Eddy McClure – West
 - e. Length: 4,925ft
2. Basic Maintenance
 - a. Brushing: **Completed**
 - b. Drainage: **Completed**
3. Trail Issues
 - a. Major retread completed along the length of the trail with MCC and volunteers, spring 2021
 - b. Brushed for sightlines
4. Recommendations, Annual Needs, and Concerns
 - a. Monitor for narrowing and brushing
 - b. Needs snag removal

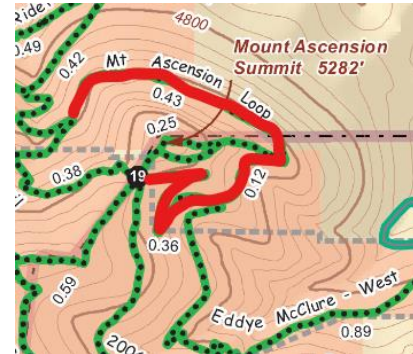
Mt. Ascension Loop Trail

1. Trail Information
 - a. Overview: This trail loops around the north side of Mt. Ascension from 2006 until it reaches the summit gradually. Dense trees in sections.
 - b. Inspection Date: 4/28/2021
 - c. Park Name: Mt. Ascension
 - d. Trail: Mt. Ascension Loop
 - e. Length: 4,699ft
2. Basic Maintenance
 - a. Brushing: **Completed**
 - b. Drainage: **Completed**
3. Trail Issues
4. Recommendations, Annual Needs, and Concerns
 - a. Monitor for brushing
 - b. Social trail on north slope closed spring 2021, with the help of the NCCC

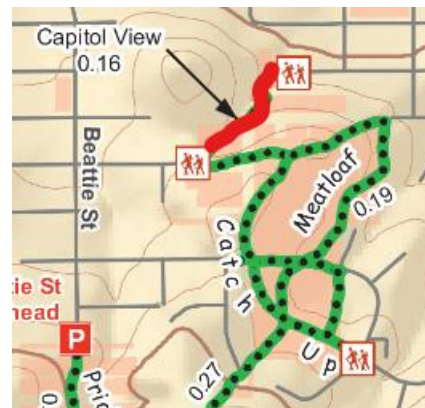
1. Trail Information
 - a. Overview: Neighborhood access to Meatloaf Hill and Mt. Ascension,
 - b. Inspection Date: 4/2/2021
 - c. Park Name: Mt. Ascension
 - a. Trail: Capital View
 - b. Length: 1,555ft
2. Basic Maintenance
 - a. Brushing: **Completed**
 - b. Drainage: **Completed**
3. Trail Issues
 - a. GPS does not match what's on the map
4. Recommendations, Annual Needs, and Concerns
 - a. Correct paper map GPS in Meatloaf area

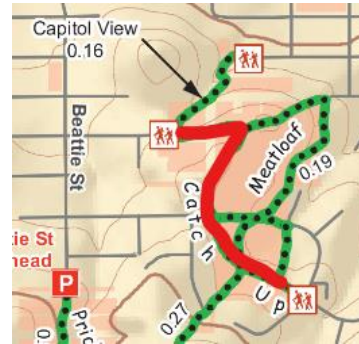
1. Trail Information
 - a. Overview: Catch Up provides access to Mt. Ascension Natural Park from the Meatloaf area.
 - b. Inspection Date: 5/12/2021
 - c. Park Name: Mt. Ascension
 - d. Trail: Catch-Up
 - e. Length: 1,759ft
2. Basic Maintenance
 - a. Brushing: **Completed**
 - b. Drainage: **Completed**
3. Trail Issues
 - a. None
4. Recommendations, Annual Needs, and Concerns
 - a. Correct GPS in Meatloaf Hill area

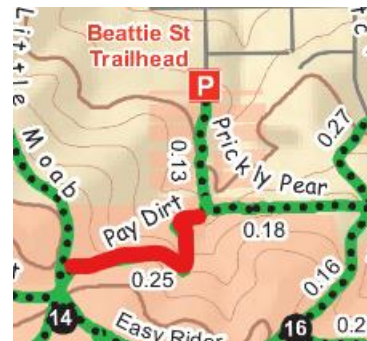
1. Trail Information
 - a. Overview: Pay Dirt connects the Beattie St. Trailhead to a five-trail junction on lower Mt. Ascension
 - b. Inspection Date: 6/3/2021
 - c. Park Name: Mt. Ascension
 - d. Trail: Pay Dirt
 - e. Length: 1,388ft
2. Basic Maintenance
 - a. Brushing: **Completed**
 - b. Drainage: **Completed**
3. Trail Issues
 - a. Reroute on lower section completed June 2021 with the help of the MCC and volunteers
 - i. Monitor reroute trail condition as it begins to be used
4. Recommendations, Annual Needs, and Concerns
 - a. Retread sections in the next few years
 - b. Widening in rocky sections

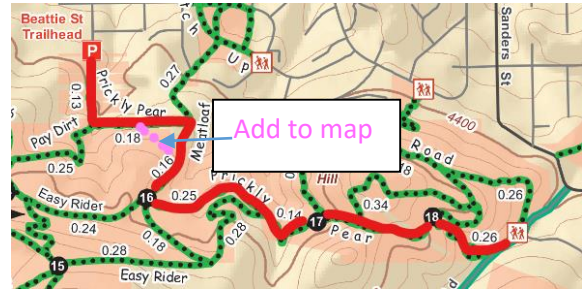
1. Trail Information
 - a. Overview: Trail that connects Beattie Street trailhead to Bompert Hill
 - b. Inspection Date: 5/21/2021
 - c. Park Name: Mt. Ascension
 - d. Trail: Prickly Pear
 - e. Length: 4,566ft
2. Basic Maintenance
 - a. Brushing: **Completed**
 - b. Drainage: **Completed**
3. Trail Issues
 - a. Segment signed, but missing from map
 - b. Social trails near Pay Dirt junction
 - c. Brushed for sightlines
4. Recommendations, Annual Needs, and Concerns
 - a. Add missing segment to map

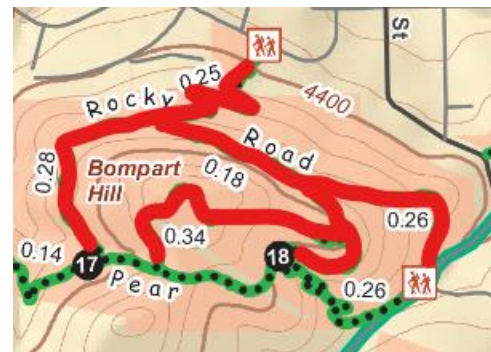
Rocky Road/Bompert Hill

1. Trail Information
 - a. Overview: Trail accessed via Diehl Drive or Lime Kiln Rd. provides access to Bompert Hill and Mt. Ascension.
 - b. Inspection Date: 4/27/2021
 - c. Park Name: Mt. Ascension
 - d. Trail: Rocky Road
 - e. Length: 7,324ft
2. Basic Maintenance
 - a. Brushing: **Completed**
 - b. Drainage: **Completed**
3. Trail Issues
 - a. Numerous social trails
 - b. GPS should be corrected
4. Recommendations, Annual Needs, and Concerns
 - a. Social trail inventory, determine if any should be incorporated or eliminated
 - b. Correct map GPS

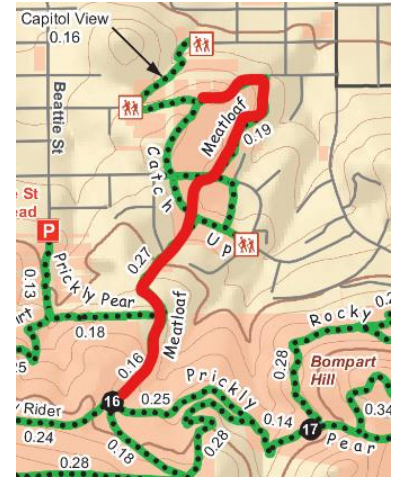
1. Trail Information
 - a. Overview: Neighborhood access trail that provides access to Mt. Ascension
 - b. Inspection Date: 5/12/2021
 - c. Park Name: Mt. Ascension
 - d. Trail: Meatloaf
 - e. Length: 2,720ft
2. Basic Maintenance
 - a. Brushing: **Completed**
 - b. Drainage: **Completed**
3. Trail Issues
 - a. Incorrect GPS
4. Recommendations, Annual Needs, and Concerns
 - a. Correct GPS throughout Meatloaf area

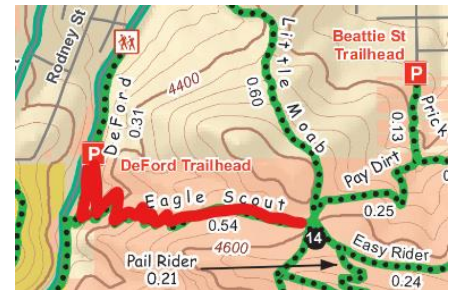
1. Trail Information
 - a. Overview: This trail uses a series of climbing turns to climb from Davis Gulch to the northern shoulder of Mt. Ascension
 - b. Inspection Date: 4/19/2021
 - c. Park Name: Mt. Ascension
 - d. Trail: Eagle Scout
 - e. Length: 2,877ft
2. Basic Maintenance
 - a. Brushing: **Completed**
 - b. Drainage: **Completed**
3. Trail Issues
 - a. Social trail closed spring 2021
4. Recommendations, Annual Needs, and Concerns
 - a. Monitor drains on upper, wide fall-line section

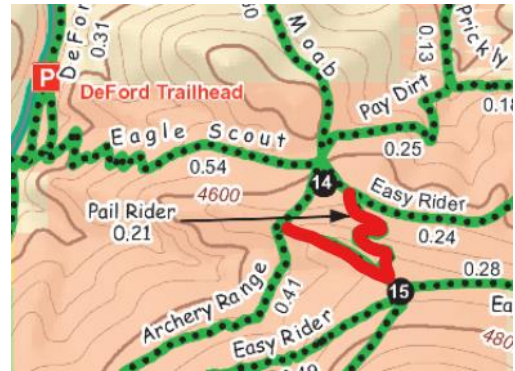
Pail Rider and Ridge Rider

1. Trail Information
 - a. Overview: Two connector trails on lower Mt. Ascension
 - b. Inspection Date: 5/21/2021
 - c. Park Name: Mt. Ascension
 - d. Trail: Ridge and Pail Rider
 - e. Length: 2,130ft
2. Basic Maintenance
 - a. Brushing: **Completed**
 - b. Drainage: **Completed**
3. Trail Issues
 - a. None
4. Recommendations, Annual Needs, and Concerns
 - a. Monitor fall-line Ridge Rider for erosion
 - b. Retread in next few years

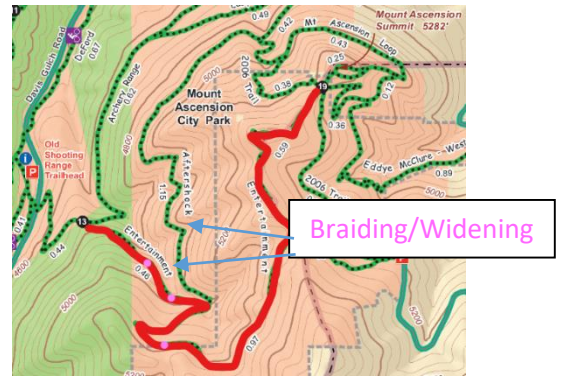
1. Trail Information
 - a. Overview: One of the most popular trails in the entire South Hills, accessed via Arrowroot Drive or Old Shooting Range trailheads. Crosses both City of Helena and USFS management
 - b. Inspection Date: 4/5/2021
 - c. Park Name: Mt. Ascension
 - d. Trail: Entertainment
 - e. Length: 10,717ft
2. Basic Maintenance
 - a. Brushing: **Completed**
 - b. Drainage: **Completed**
3. Trail Issues
 - a. Braiding and widening
 - b. Polesaw brushing in Entertainment Woods
4. Recommendations, Annual Needs, and Concerns
 - a. Trail is widening each year and become more and more of a maintenance issue
 - b. Needs to be monitored and fixed annually
 - c. Steep Entertainment Alternate needs annual drain maintenance (has been removed from trail map)

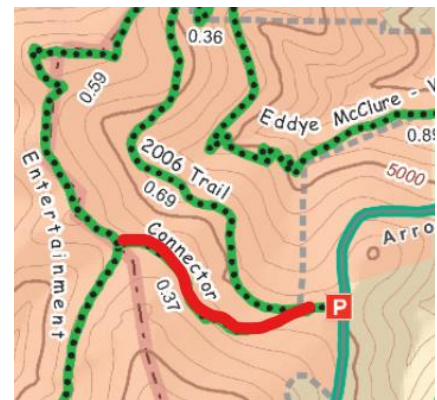
1. Trail Information
 - a. Overview: Connector trail from Arrowroot trailhead to Entertainment trail
 - b. Inspection Date: 4/5/2021
 - c. Park Name: Mt. Ascension
 - d. Trail: Entertainment Connector
 - e. Length: 1,710ft
2. Basic Maintenance
 - a. Brushing: **Completed**
 - b. Drainage: **Completed**
3. Trail Issues
 - a. None
4. Recommendations, Annual Needs, and Concerns
 - a. None

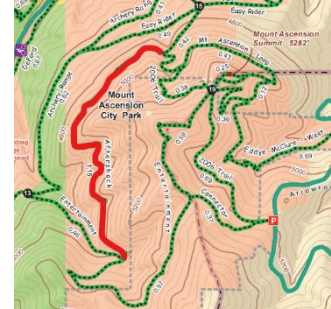
1. Trail Information
 - a. Overview: Contour trail above Archery Range trail between 2006 and Entertainment.
 - b. Inspection Date: 4/2/2021
 - c. Park Name: Mt. Ascension
 - d. Trail: Aftershock
 - e. Length: 6,015ft
2. Basic Maintenance
 - a. Brushing: **Completed**
 - b. Drainage: **Completed**
3. Trail Issues
 - a. Rock structures need repair
 - b. General widening and flattening of outsloped tread
4. Recommendations, Annual Needs, and Concerns
 - a. Substantial retread required next year
 - b. Two rocky sections require cribwall or other structures to maintain tread integrity

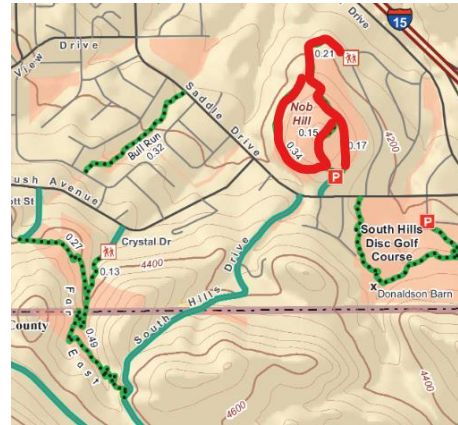
1. Trail Information
 - a. Overview: Nob Hill is an island of open space surrounded by Private Property, popular neighborhood trail.
 - b. Inspection Date: 4/20/2021
 - c. Park Name: Nob Hill
 - d. Trail: Nob Hill
 - e. 4,997ft
2. Basic Maintenance
 - a. Brushing: **Completed**
 - b. Drainage: **Completed**
3. Trail Issues
 - a. Inaccurate GPS on map
 - b. Neighborhood social trails
4. Recommendations, Annual Needs, and Concerns
 - a. Revisit GPS and social trails to correct map
 - b. Determine which social trails to adopt and which to close
 - c. Portion of Nob Hill burned in September, trail impacts will be monitored

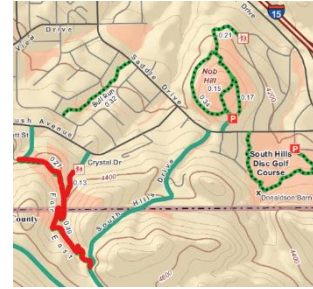
1. Trail Information
 - a. Overview: Island trail between South Hills Drive and Winscott and Crystal Drives. Old Lime Kiln along Trail.
 - b. Inspection Date: 4/14/2021
 - c. Park Name: Other
 - d. Trail: Far East
 - e. Length: 3,480ft
2. Basic Maintenance
 - a. Brushing: **Completed**
 - b. Drainage: **Completed**
3. Trail Issues
 - a. Social trails along trail
4. Recommendations, Annual Needs, and Concerns
 - a. Analyze social trails

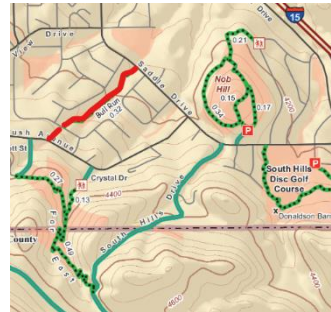
Bull Run Trail (California to Saddle, Gold Rush to California)

1. Trail Information
 - a. Overview: Neighborhood connector consisting of two segments: California to Gold Rush and California to Saddle Drive.
 - b. Trail Inspection Date: 7/21/2021
 - c. Park Name: Other
 - d. Trail: Bull Run
 - e. Length: 1,910ft, 267ft
2. Basic Maintenance
 - a. Brushing: **Completed**
 - b. Drainage: **Completed**
3. Trail Issues
 - a. Weed spraying on decomposed granite portion between California and Gold Rush
4. Recommendations, Annual Needs, and Concerns
 - a. Monitor fall-line on section between Saddle and California
 - b. Improve access between sidewalk and trail and sidewalk and street for accessibility
 - c. Decomposed Granite resurfacing

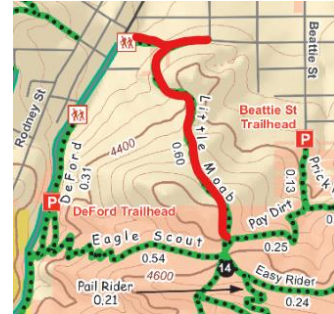
1. Trail Information
 - a. Overview: Rocky trail between Davis Gulch and the top of Eagle Scout and Pay Dirt trails. Crosses City as well as private properties.
 - b. Inspection Date: 4/9/2021
 - c. Park Name: Other
 - d. Trail: Little Moab
 - e. Length: 2,994ft
2. Basic Maintenance
 - a. Brushing: **Completed**
 - b. Drainage: **Completed**
3. Trail Issues
 - a. Steep pitch on city to Second Street connection, needs drainage
4. Recommendations, Annual Needs, and Concerns
 - a. Users respecting private property is a concern, could lose trail if landowners disallow access
 - b. Retread on sidehill needed
 - c. Monitor fall-line section towards Second Street connection
 - d. Requires brushing for sight line purposes
 - e. Limited maintenance ability without private landowner permission

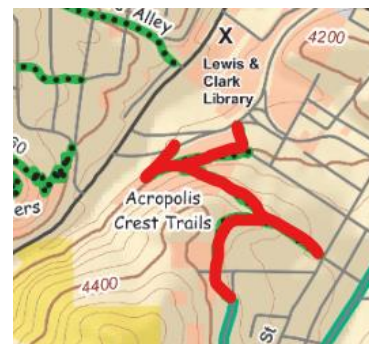
1. Trail Information
 - a. Overview: Neighborhood connection, connects to Park Ave via Cruse Ave.
 - b. Inspection Date: 5/31/2021
 - c. Park Name: Other
 - d. Trail: Acropolis Crest
 - e. Length: 2,692ft
2. Basic Maintenance
 - a. Brushing: **Completed**
 - b. Drainage: **Completed**
3. Trail Issues
 - a. Section towards Cruse has some tread issues and social trail issues
4. Recommendations, Annual Needs, and Concerns
 - a. Improve trail access to road
 - b. Consider trail along Cruse grass island open space
 - c. Fix tread issues on lower section of trail
 - d. Requires brushing for sightline concerns

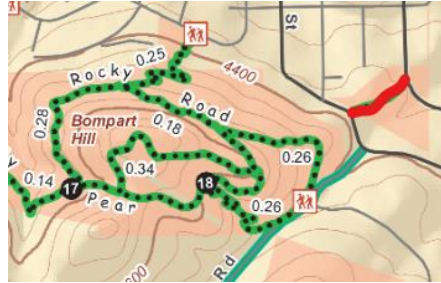
1. Trail Information
 - a. Overview: Connector trail between Virginia Dale and Belt View. Near Rocky Road trails
 - b. Inspection Date: 5/3/2021
 - c. Park Name: Other
 - d. Trail: Virginia Dale
 - e. Length: 482ft
2. Basic Maintenance
 - a. Brushing: **Completed**
 - b. Drainage: **Completed**
3. Trail Issues
 - a. None
4. Recommendations, Annual Needs, and Concerns
 - a. Monitor for water erosion
