Downtown Study Area Draft Statement of Blight

City of Helena

March 15, 2018

WGMGROUP™

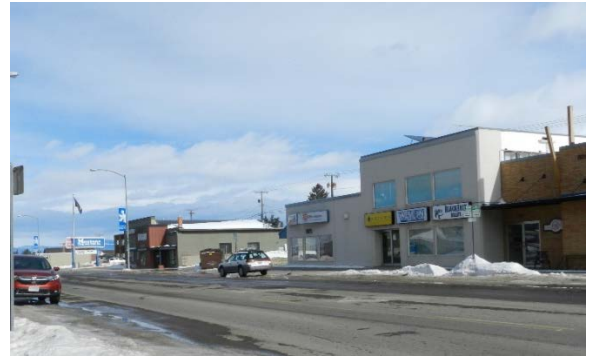
Building gaps located at North Last Chance Gulch

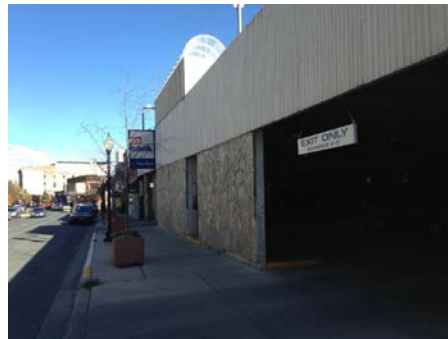
Parking lot structure on Last Chance in retail core of historic Downtown

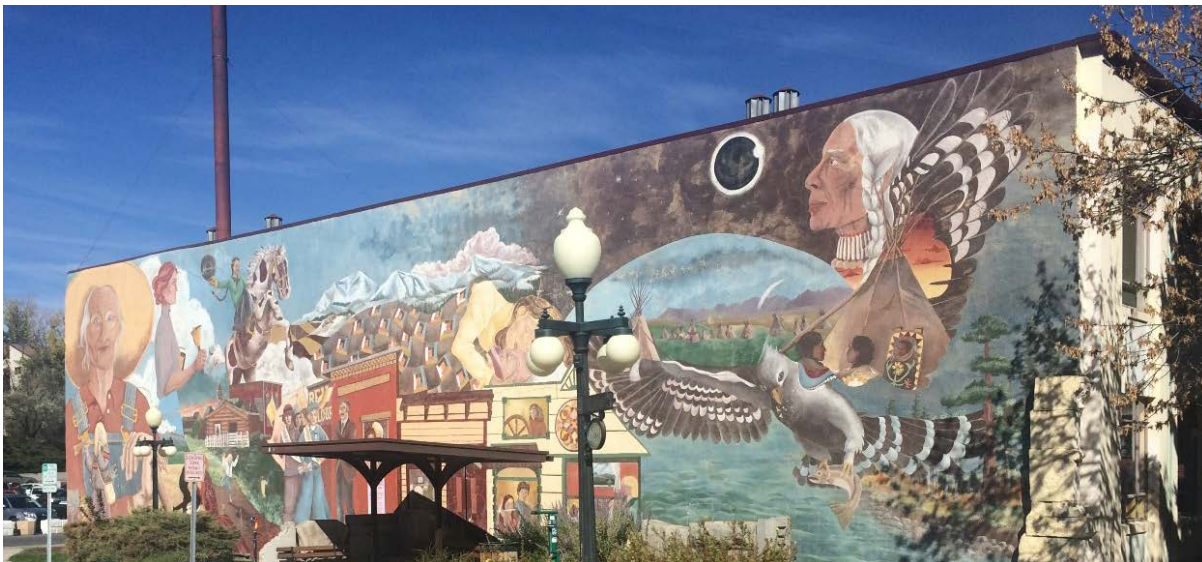
Downtown artwork completed or renovated during the 20th century urban renewal is also beginning to show signs of deterioration. The women’s mural, significant for its art and as a location for activities such as the mountain bike shuttle, is seriously deteriorating and in need of repair.

Women’s Mural at Broadway and the Walking Mall

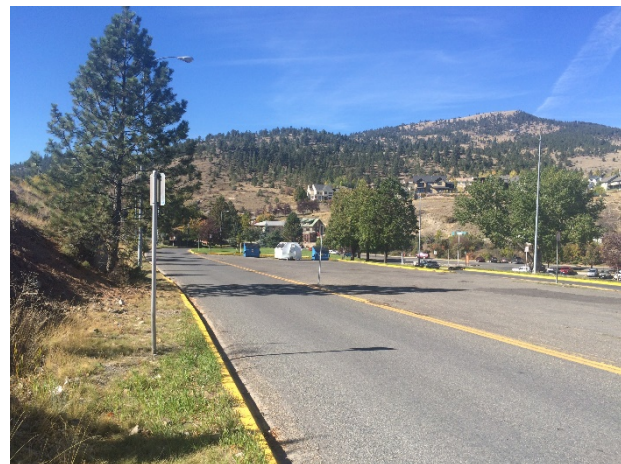
*Cruse Avenue to form on/off ramps
Note: Use of empty space for recycling containers*

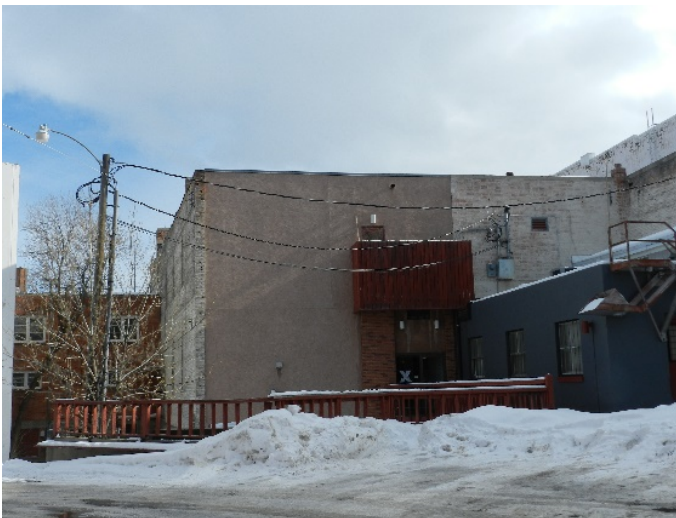
View from Fuller Avenue of a double-frontage lot with store front on North Last Chance

The unique street layout results in double-frontage lots and odd shaped lots at intersections that can affect usefulness. Double frontage lots usually occur when blocks are very narrow. These lots have direct access to streets at the front and back of the lot. Examples include three lots between Fuller and Last Chance near 6th Avenue. When buildings do not have storefronts on both streets, the back of the building can appear to be more like an alley approach than a main street.

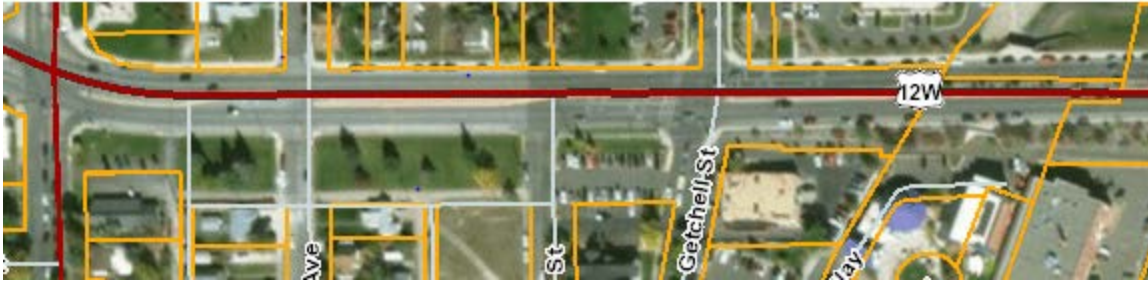
Large right of way area between Benton and Getchell on US 12/W Lyndale
